**The Richfield Groundwater Monitoring Program:
Background and Results from the First 10 Years**

D. S. Cherkauer, Hydrogeologist (PG, PH) and Richfield resident

December, 2013

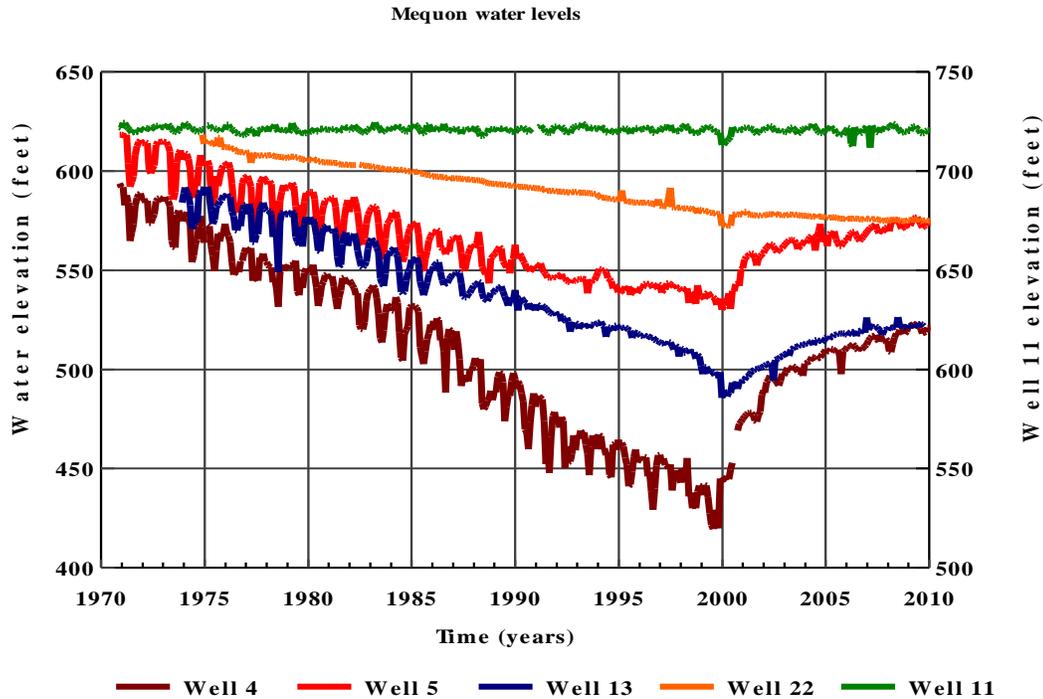
Figure 1 Historical groundwater levels in private wells in Mequon, WI
Wells 4 and 13 are near the center of a cone of depression in the water table
which developed due to residential and commercial pumping without return
of water to the aquifer. The cone is centered near the intersection of
Port Washington and Donges Bay Roads. Well 5 is about a mile to the west,
and well 22 is about a half mile south. Water elevations for those 4 wells all
refer to the axis on the left. Well 11 is 6 miles to the west, and its levels
are shown on the right hand axis. Treated wastewater is returned
to the aquifer in this western part of Mequon.

The result was that water levels were dropping and the area underlain by a declining water table was expanding until 2000. In 2000, portions of Mequon began to receive Lake Michigan water from the Milwaukee Municipal Water System. As you can see in Figure 1, the water table in parts of the city rebounded for the next 5 to 7 years. After that, the water levels either stabilized or started to decline again as the demand for water from further development continued to rise. Wells in areas away from the concentrated development (wells 22 & 24 in Figure 1) showed a slower decline and also no rebound, because they are away from the area where city water has been supplied.

The Mequon monitoring program is focused on the areas of most concentrated development. There are only 3 wells monitored in the western third of the city, but they have shown very little change in water level through time (see well 11 on Figure 1).

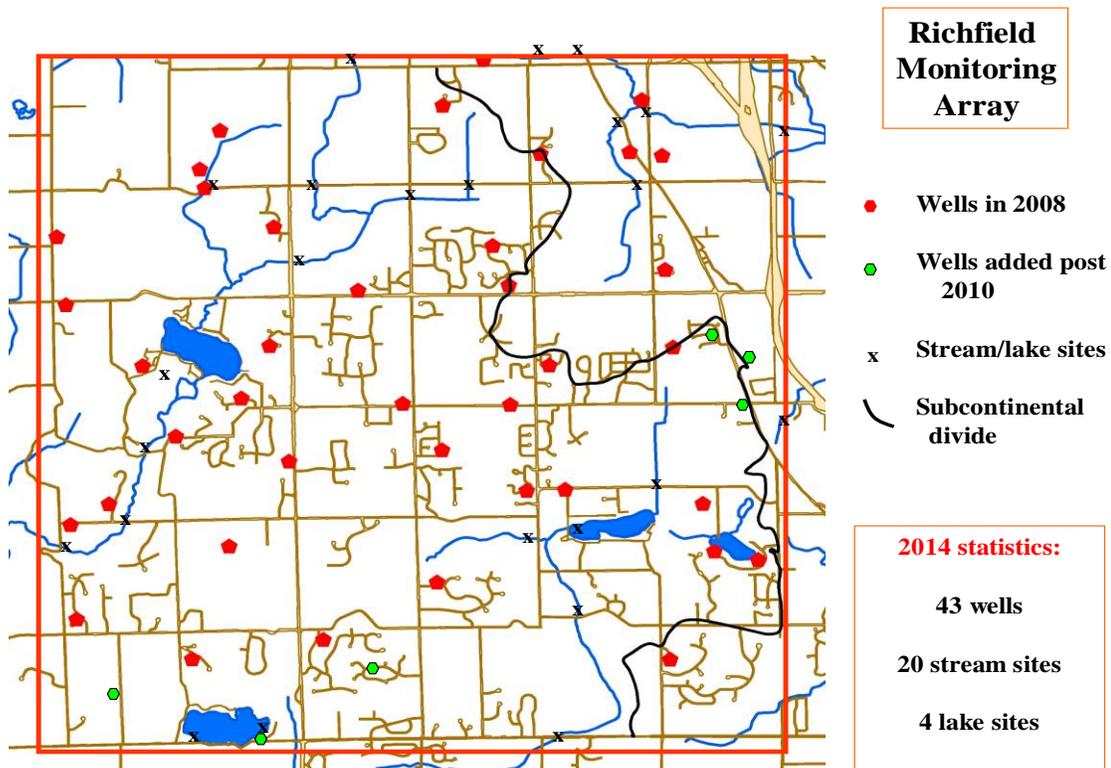
Figure 2 The Richfield Monitoring Array in early 2014
The red line roughly highlights the boundaries of Richfield.
The road system (brown lines) shown on the map may not include your road, because it shows the roads the existed in 2000, the latest GIS data the author had access to at the time this article was prepared. For scale, the continuous roads running north-south or east-west are sections line roads, so they are a mile apart. The subcontinental divide separates the Great Lakes surface watershed (to the east) from the Mississippi River watershed (to the west).

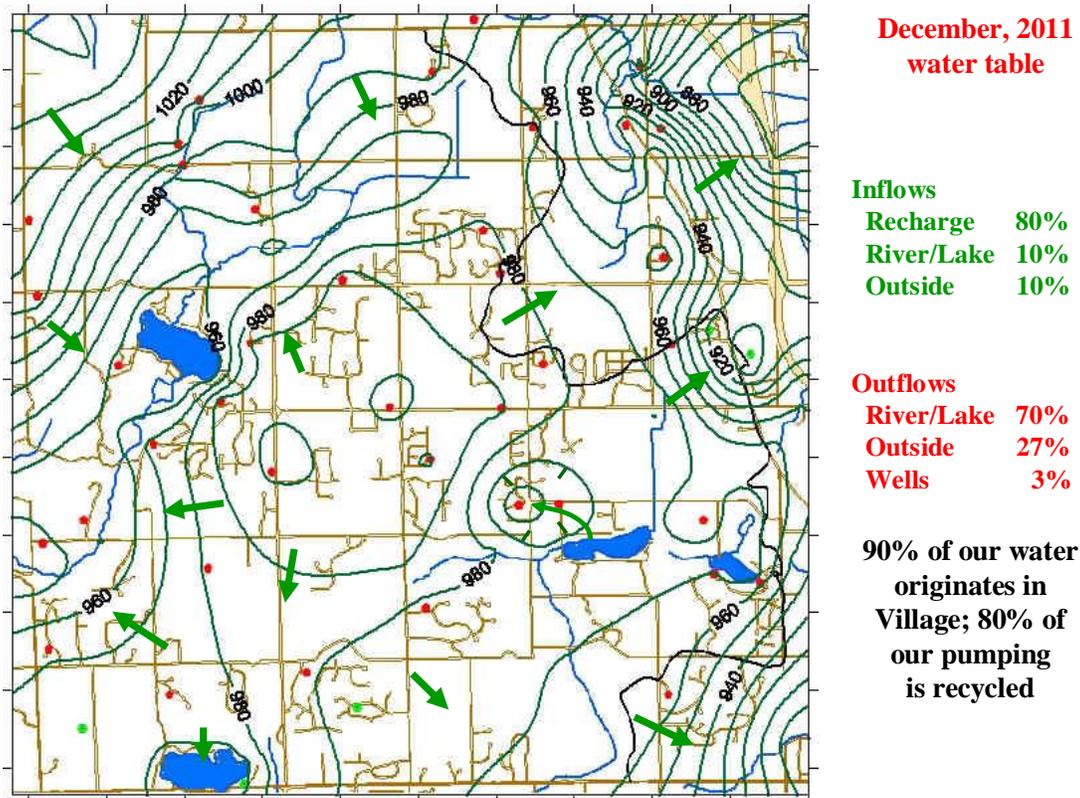
Figure 3 Water table map and groundwater budget for Richfield in December, 2011
 Green lines are contours of equal elevation on the water table. Contour interval is 10 feet. Groundwater flows from high water table to low. Green arrows added to show basic directions of flow. Note that groundwater can flow underneath the subcontinental divide (black line across eastern Richfield), which separates the surface watersheds of the Mississippi River (to west) and the Great Lakes/St. Lawrence River watershed (to east). Note also that the area just northwest of Bark Lake is a groundwater depression into which groundwater is flowing.

A water table map allows us to determine the direction of groundwater flow, because groundwater flows down the gradient on the water table. In Richfield, our highest groundwater elevations are in the center of the Village, near Village Hall at the intersection of Hubertus Road and Hillside Drive (Figure 3). Flow is radially outward from that high until groundwater discharges in the Oconomowoc River and Friess Lake to the north and west, Cedar Creek to the northeast, and the Bark and Menomonee Rivers and Bark and Amy Belle Lakes to the southeast. Along the east side of the Village, groundwater is also flowing into Germantown to the east.

in Figure 3 and measured groundwater discharges in a number of streams. Once that is done, the model can be queried to determine the magnitudes of the water flowing through the system: the groundwater budget. While this budget changes a bit from wet to dry periods, typical values are shown on the right of Figure 3.

Recharge is far and away the largest source of water for Richfield's groundwater (Figure 3), constituting 80% of inflow. Another 10% is groundwater flowing in from outside the Village. The remaining 10% is drawn from surface water bodies., mostly wetlands, but also lakes and streams in areas where pumping is occurring.

On the outflow side of the budget, the bulk of the groundwater discharges either to surface water bodies (70%) or flows into neighboring communities (27%, Figure 3). The net pumpage out of all our wells (pumpage minus return) is estimated to be only a little over 300,000 gallons per day. We probably pump as much as 1.5 Mgd out of the ground, but something on the order of 1.2 Mgd flows back into the ground through our septic and mound systems. These pumping amounts are only estimates, because almost none of the wells in Richfield are metered. Only a few high capacity wells, such as those at the Kettle Hills golf course and the Reflections Village development, are required to report their pumping to the WI DNR.

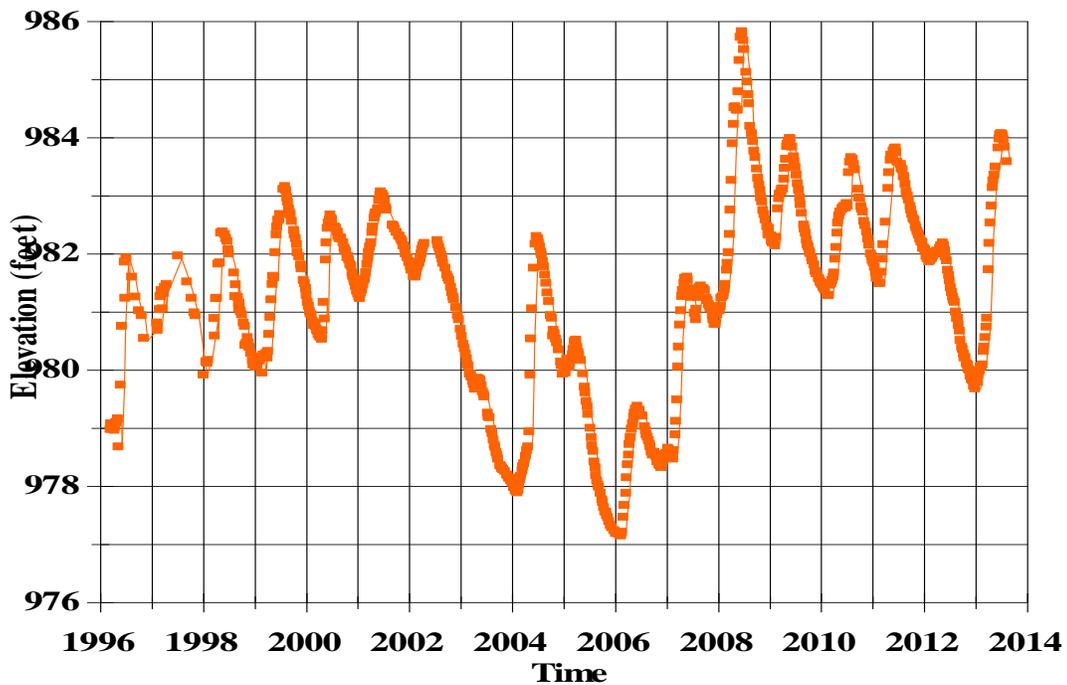
Figure 3 Historical water elevations in the author's well
The vertical lines are drawn on January 1 of each year, with the even year labels centered under their line. The space between the vertical lines labeled 2006 and 2008, for example, represents January 1, 2006 to January 1, 2008. Readers can visually interpolate within that time frame, with the water level cresting around June 20 in 2006.

Groundwater levels do change through time, largely in response to natural conditions, but sometimes due to human pumping or paving. Figure 4 shows the history of water elevations in my own well, where I have been measuring water levels since shortly after I moved to Richfield. I try to monitor the well weekly, although vacations and weather sometimes prevent my achieving that frequency.

The record in my well is typical for water levels throughout Richfield. Our primary recharge occurs when the ground thaws during the annual snowmelt, generally in March. The water level in my well typically peaks between 3 and 4 months later, in mid to late June. The water table is around 123 feet below the ground surface, which means that it takes months for the bulk of the annual recharge to reach it after the spring snowmelt. In wells where the depth to water is much smaller, the response to recharge is much quicker.

There is a rise in water level in the well each year which can range from less than 3 inches (2003 and 2012) to 4 to 5 feet (2004, 2008 and 2013). The peak elevation occurs when the annual recharge reaches the water table. After that there is a slow decline in water elevation throughout the summer, fall and winter. Once the ground starts to thaw, sometimes with a January thaw, followed by subsequent refreezing, water begins to work its way into the ground. The water table starts a slow rise as early as January (Figure 3). This is due to early recharge having reached the aquifer in other nearby areas where the depth to water is much smaller. The bulk of the recharge local to my well doesn't reach the water table until June, which is when the water level crests.

Over longer periods of time, the water elevation has varied from 977 to 986 feet, a range of nearly 9 feet, with lows occurring in dry years and highs in wet ones. When we have 2 wet years in a row, such as 2007 and 2008, the water elevation rises dramatically. In dry years like 2003, 2005 and 2012, the water table throughout Richfield drops notably. This can actually cause problems with your well. If you and your neighbors are irrigating your plants heavily and your pump is set relatively high in the well, the water table can drop below your pump. The well is not actually dry, but this situation may cause your pump to burn out.

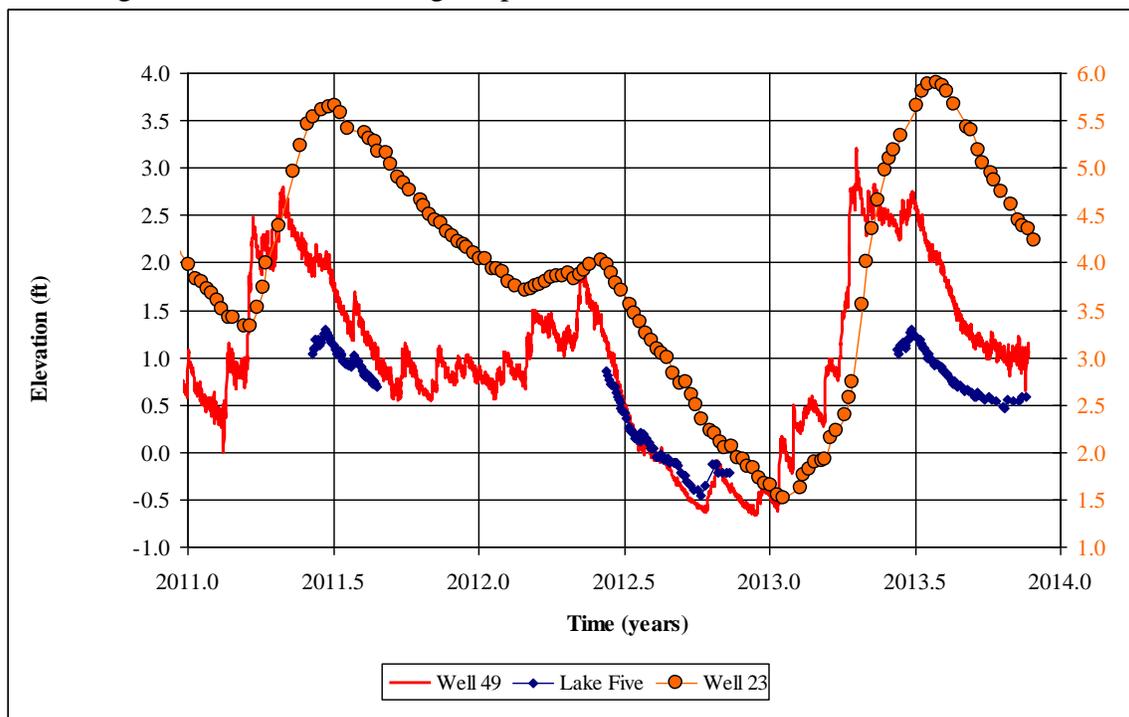
Figure 4 Comparison of relative water elevations in wells and a lake
Water levels over the past 3 years in Lake Five and two frequently monitored wells
are shown. Lake Five level has only been measured during the summer season.
The lake and Well 49 levels refer to the left vertical axis. Well 23 uses the right axis,
which is displaced to allow better comparison.
Location of the wells is shown on Figure 9 later in this article.

There is also correlation between water level in different wells and in surface water bodies (Figure 4). The water level in my well (Number 23 in the monitoring array) is measured weekly. Well 49 is a piezometer built to serve as a dedicated monitoring site; it has no pump to affect water level and it has been fitted with a transducer that measures water level every 4 hours. The average depth to water in these 2 wells is about 120 feet in 23 and 11 feet in number 49. In addition, residents along Lake Five have been measuring lake water levels during the past 3 summers.

As can be seen in Figure 4, water levels in all 3 locations generally parallel each other, rising in the spring and then falling the rest of the year. This demonstrates that this lake, which has no surface inlet or outlet, is directly connected to the groundwater

The responses to precipitation in the lake and Well 49 show exceptional similarity, even though Well 49 is nearly 6 miles north of the lake (Figure 9). This demonstrates that there is very little time lag as water infiltrates through 11 feet of sand at Well 49. In contrast, water level responses in Well 23 lag behind Well 49's response, usually by 1 to 2 months. This is the time it takes infiltrated recharge to travel the extra 110 feet to the water table at Well 23. Notice also that the water level plot for Well 23 is much smoother than that in Well 49, indicative of mixing of the infiltrating water as it travels that extra distance. The water level in Well 49 responds to individual rainfall events (Figure 4), while that in Well 23 does not.

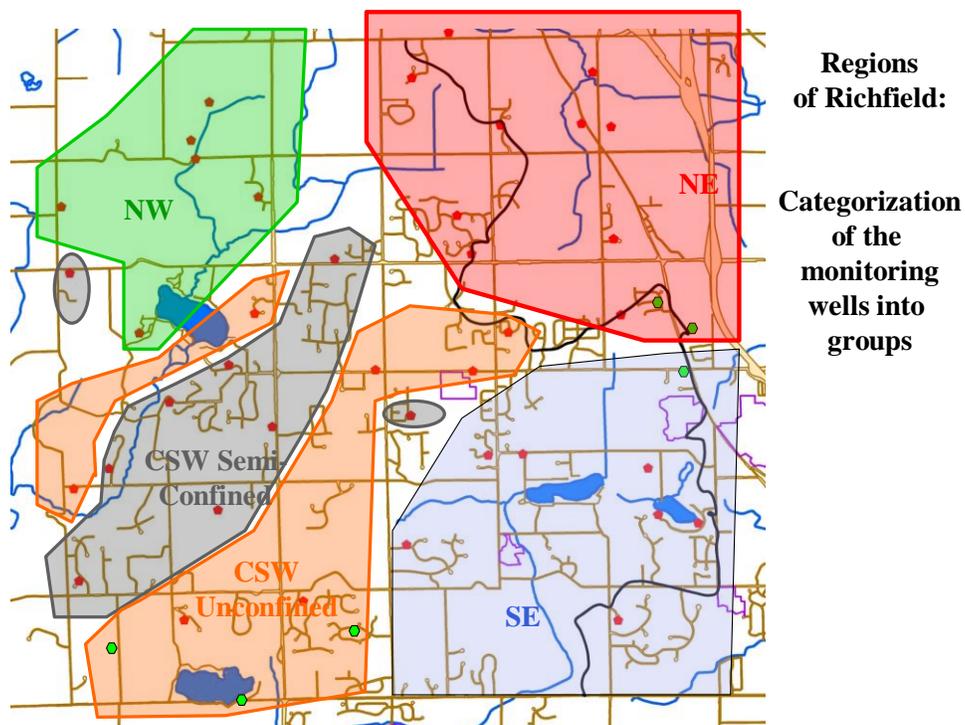
Figure 5 Subdivision of Monitored Wells into Five Categories
 The well array consists of 6 wells in the northwest (NW) region; 12 in the northeast (NE); and 8 in the southeast (SE) geographic regions. Wells in the southwest and central parts of the Village are grouped according to their hydrologic response. There are 10 in areas where the shallow aquifer is unconfined (CSW-unconfined) and 8 where the shallow aquifer responds as if semi-confined (CSW-semiconfined). Wells are the red and green dots.

A first step in the analysis of the historical water level records was to subdivide the wells into geographic categories. Initially 5 areas were selected arbitrarily: northeast (NE), northwest (NW), southwest (SW), southeast (SE) and central (C). In the first 3 areas, most wells responded as if they were in an unconfined aquifer; water levels rose shortly after the spring recharge, peaked in May and June, and then dropped during the remainder of the year. These 3 areas can be seen in Figure 5.

Within the SW and C zones, however, there were 2 distinct patterns of water level response observed which were independent of geography. About half the wells responded to the spring recharge as if they were in an unconfined aquifer. Those have been identified on Figure 5 as lying within a zone called Unconfined. The remainder of the wells responded much differently, often not showing a recharge rise until late summer or fall, and then declining through winter and spring. This delayed response indicates that these wells are in a part of the shallow aquifer where the connection to the ground surface is much more complex. There is probably considerable clay in the geologic materials between the well bottom and the surface, forcing infiltrating water to travel longer distances to get around the clay. These wells are designated on Figure 5 as being in a Semi-confined aquifer; partially confined because of the very slow response, but not fully confined because water from the surface does reach them.

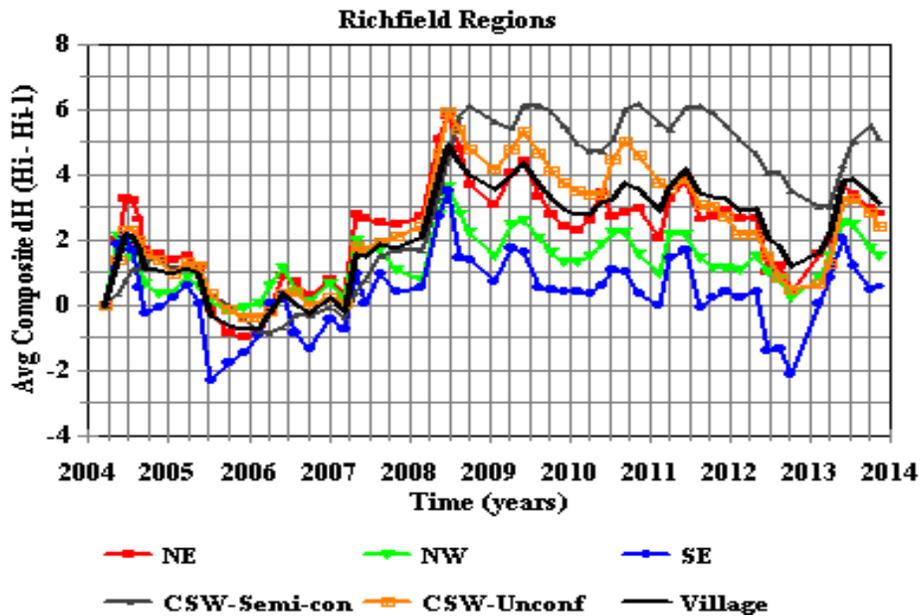
Figure 6 Changes in average groundwater elevation during the monitoring period for the regions shown in Figure 5.

Each point plotted is the average change in elevation from March, 2004, for a given region. Points plotting above 0 show a net water level rise; those below 0 show a net decline since March, 2004. The black line without markers shows the average for all wells in the monitoring array.

Figure 6 plots the average change in groundwater level in each of the 5 regions in Richfield through the entire length of the monitoring program. The average elevation within each region in March, 2004, was arbitrarily identified as the baseline (0 relative elevation). If the line for a particular region plots above 0, then the average water level has risen relative to the start of the monitoring program. Conversely, if a line plots below 0, then the average water elevation has decreased.

Several important patterns emerge in Figure 6. For the first 4+ years of monitoring, all 5 regions showed very similar patterns; they went down in the drier years of 2005 and 2006, and then rose through 2007 into 2008. In 2008, Richfield's recharge and subsequent water levels were the highest observed during our monitoring program to date. Levels in all regions rose notably (Figure 6), but after the summer of 2008 the five regions responded differently to this large influx of water.

In SE and NW Richfield, water levels dropped much more quickly than in the other areas, and they have remained relatively lower. In the CSW area, groundwater levels stayed high for 3 to 5 years after 2008. The wells in the unconfined aquifer area fell back toward the other regions after about 3 years (Figure 6), while those in the semi-confined aquifer remained high for 5 years. The water levels in the semi-confined aquifer also lagged behind those in their neighboring unconfined wells (crests in semi-confined level typically were 1 or 2 measuring periods behind those in the unconfined). The wells in the NE area generally tracked in the middle of Figure 6.

Last year (2013) was another very wet one. As can be seen on Figure 6, water levels for all 5 Richfield regions rose, and more importantly the levels in all the regions converged back to where they are only about 3 feet apart. At this time, we don't know why.

It's very important to note that all the regions ended 2013 with average groundwater levels higher than they were in 2004 (figure 6). In addition, almost all of the

regional averages plot above 0 on Figure 6 for most of the monitoring period. This tells us that over the last 10 years Richfield's groundwater levels have risen. The rise has been an average of from 0.7 to 4.9 feet for individual regions and an average of about 3 feet for the Village as a whole. In addition, all but 3 of the individual wells monitored since 2005 had higher water levels in 2013 than 2005. During the monitoring period, the quantity of Richfield's groundwater supply has remained very strong.

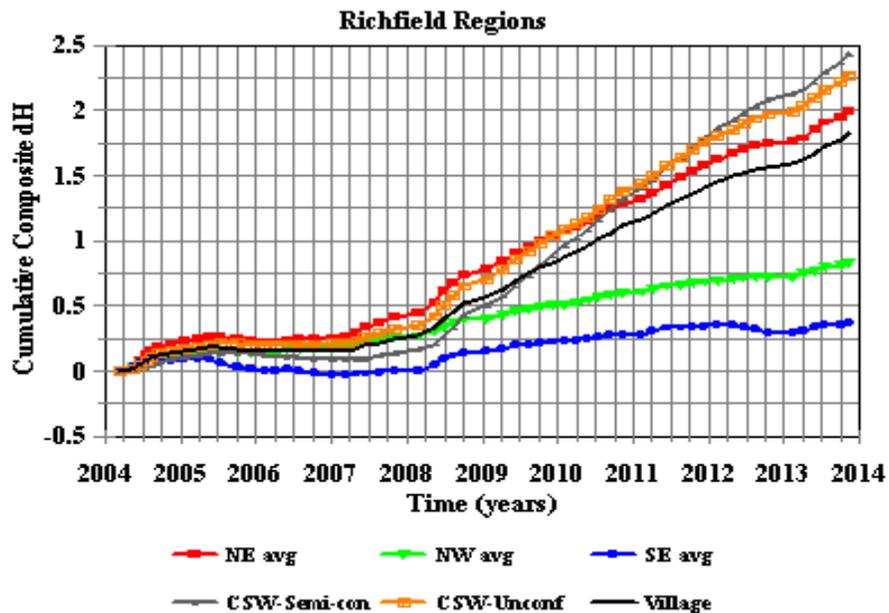
Figure 7 Accumulated change in water elevation through time.
All regions within Richfield have shown a net increase (upward trend on the line) during the 10 year monitoring period. Only the SE area ever dropped below 0 to indicate a net decline in water level from 2006 to 2008.
The Village average is the black line.

Presenting the results for the Richfield areas in different ways may make trends somewhat easier to see. In Figure 7, the changes in water level shown in Figure 6 are accumulated through time so that you can see the overall trend. This shows that all regions have seen water level increases during the monitoring period, but that the SE and NW area increases have been smaller than elsewhere.

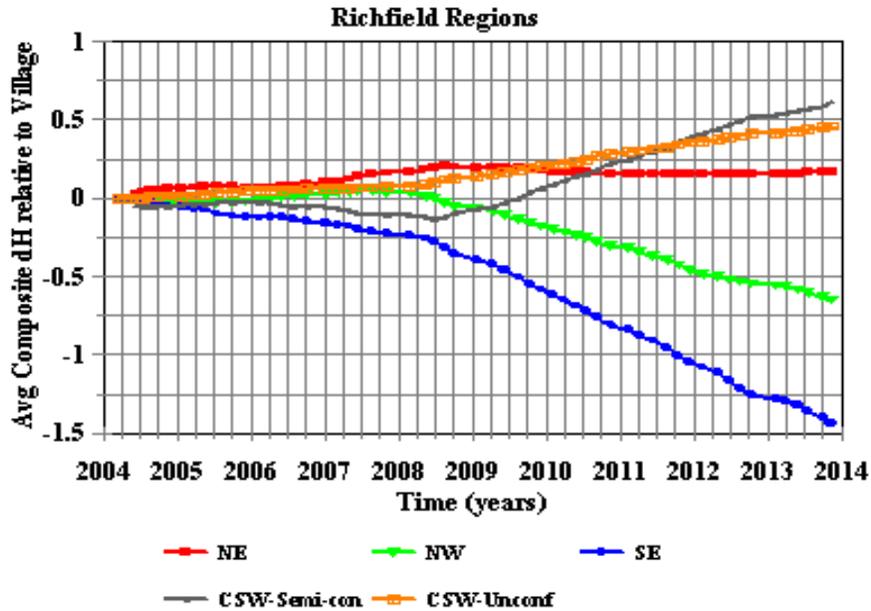
Figure 8 Change in average water level through time relative to Village average. A downward trend shows a region's water level is not increasing as much as the Village as a whole. An upward trend indicates the opposite.

Figure 8 shows how each region has responded relative to the Village average water level. In it, the difference between a region's average and the Village average in Figure 7 has been plotted through time. If a region has increased more than the Village average, it plots above 0 on Figure 8. If it plots below 0, then its water level has not increased as much as the Village as a whole. It becomes clear that water levels in the SE and NW regions have not risen as much as those in the rest of the Village.

Figure 8 also shows that this pattern actually has been going on the entire monitoring period (blue and green lines plot the lowest in Figure 8). Initially the NE (red line) plotted the highest. Once again, in 2008 the patterns changed dramatically. The CSW regions increased much faster, while the SE and NW began to drop off and the NE region leveled off. The cause of this change in pattern remains unknown at this time.

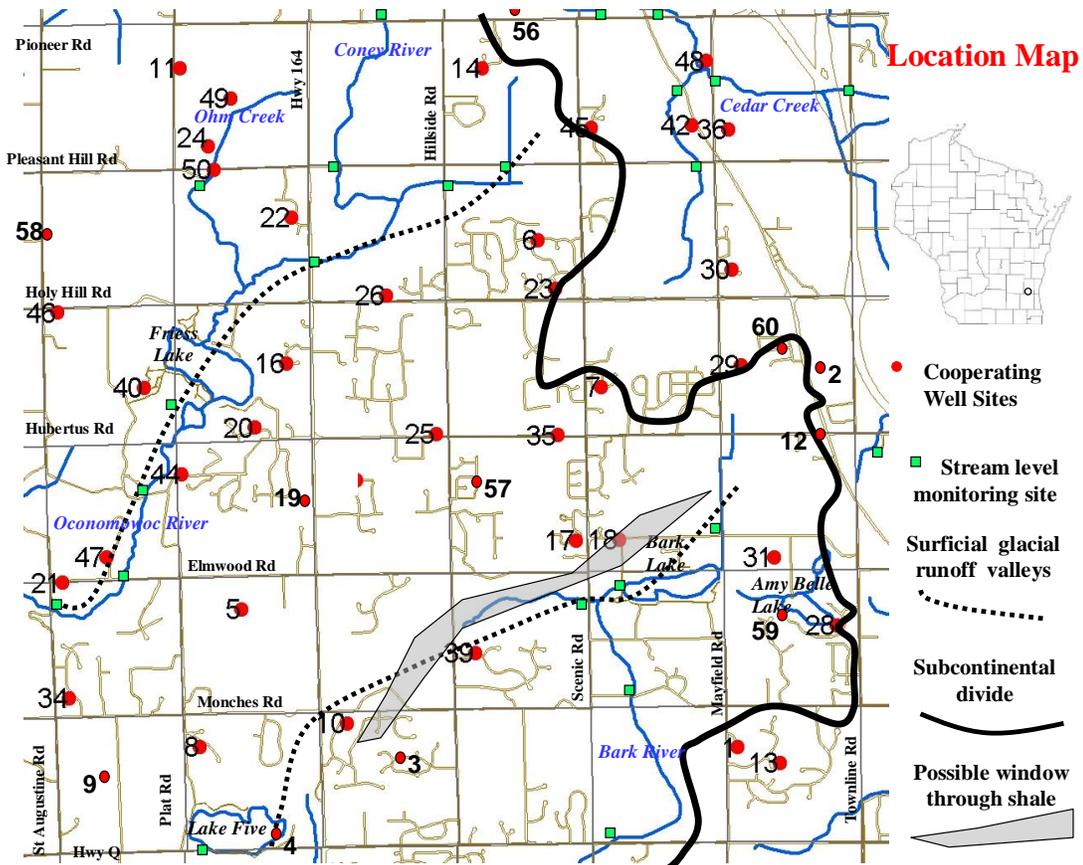
Figure 9 Location of Monitoring Sites

The wells are identified here with their numerical designation to allow correlation with subsequent figures. The glacial runoff valleys are explained in the article on Richfield's hydrogeology on this website.

The existing monitoring array (shown in Figure 9) is generally adequate to allow identification of negative impacts at these locations. We have added wells 2, 12 and 60 (Figure 9) to the array in recent years to give better coverage along Highway 175.

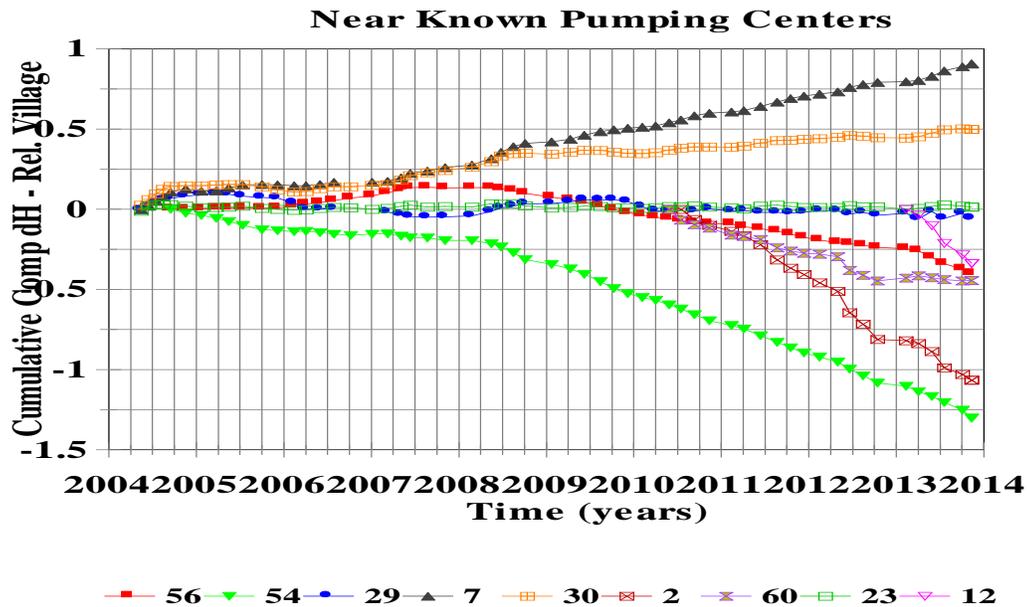
Figure 10 Change in groundwater level in wells near pumping centers relative to Village average

Wells 54 and 56 are near an active sand/gravel extraction site north of Pioneer Road and west of Scenic Road. Wells 29 and 7 are near the golf courses along Holy Hill Road. Well 30 is closest to the baseball fields at Holy Hill and Highway 175. Wells 2 and 60 are near the residential development along Highway 175 and south of Holy Hill.

As can be seen in Figure 10, the well closest to Richfield (Well 56) has not shown any significant downward trend in relative water level, while Well 54 does. This indicates that the quarrying operation may have an impact on groundwater levels, but that impact is occurring only to the north of the quarry. The return of the wash water through the infiltration ponds eliminates groundwater level impacts to the south. In fact, the nearest well in Richfield (Well 14 on Figure 9, but not shown on Figure 10) actually shows a modest water level increase relative to the Village average. In short, the sand/gravel operation is not impacting Richfield's groundwater level.

Well 12 is about 0.5 miles south of the Reflections well. It was added to the monitoring array in late 2012, so it has a very short record on Figure 10. However, the early results show a rapid decline relative to the Village average. It is showing a more rapid decline in water level relative to the Village than even Well 2. Because Well 12 is some distance away from the Reflections Village pumping well, its response is probably due to pumping wells south of Reflections. A search of the WI DNR website has not yet found pumping rates for such wells, however.

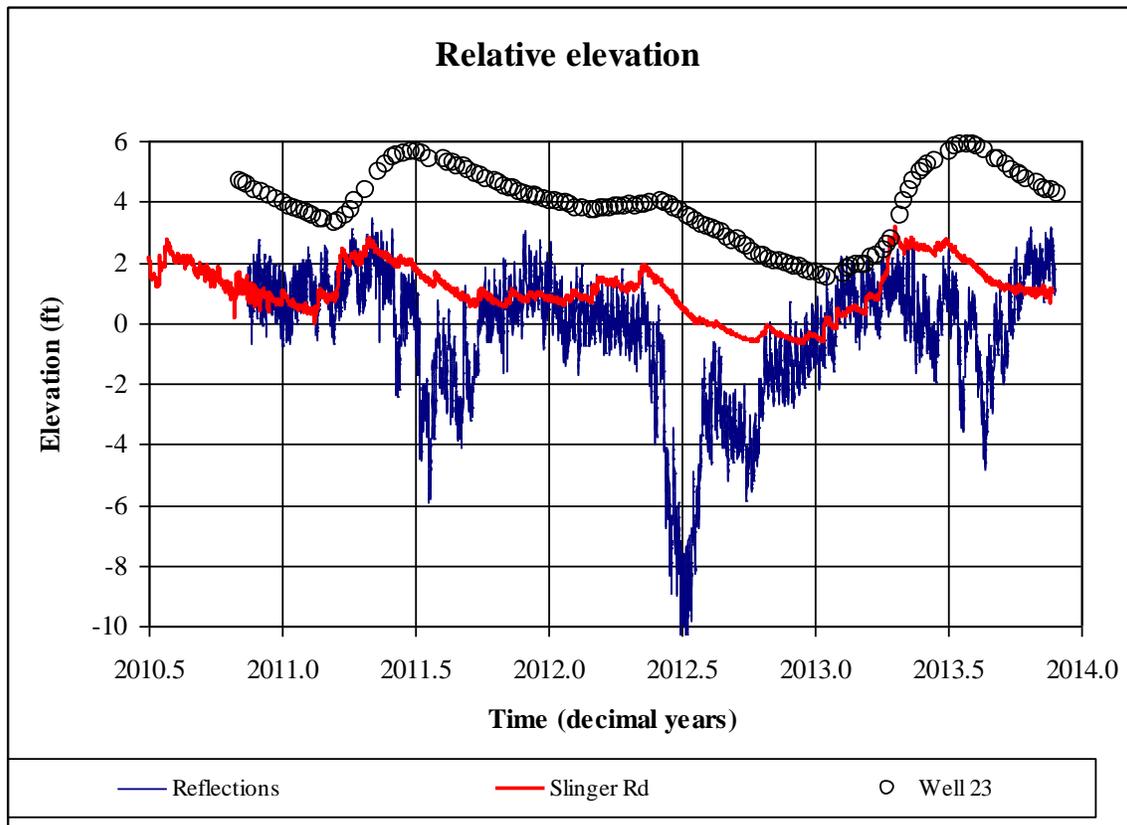
Figure 11 Comparison of the water level in the Reflections observation well with other frequently monitored sites.

"Slinger Rd." is Well 49, Well 23 is the author's, and "Reflections" is Well 2 in Figure 9. In addition to the seasonal level changes which the other 2 wells exhibit, the Reflections well shows a pronounced drop in water level during the summer months (from 2012.4 to 2012.8, for example).

A transducer has been measuring water level every 2 hours in the Reflections well since June, 2011. With the exception of summertime, the water level pattern is remarkably similar to that in Well 49 (Slinger Rd.), despite major differences between the 2 wells. They are nearly 6 miles apart (Figure 9). Well 2 (Reflections) is 300 feet deep, and is in the dolomite with an average depth to water of over 130 feet. In contrast, Well 49 is only drilled 30 feet into the sand and gravel and has an average depth to water of about 11 feet.

In the summer, the water level in Well 2 drops notably and rapidly, while that in Well 49 continues its seasonally decline. Toward the end of September, the water level in Well 2 rises back to roughly that in Well 49. This is indicative of heavy local pumping in or around Well 2, and the distance between the water level lines of the 2 wells on Figure 11 is a rough estimate of how much the dolomite's local water level is drawn down.

Based on what is known about the hydrogeology around the Reflections site, the Reflections pumping well is probably not the sole cause of the summer drawdowns observed in Well 2. Even the large pumping rates of summer, 2012, cannot fully explain the 8 feet of drawdown that seems to be shown on Figure 11. It could be that there are other large, and as yet unidentified, pumping wells near the Reflections site, but examination of the WI DNR records for high-capacity wells hasn't revealed any that should be active only in the summer.

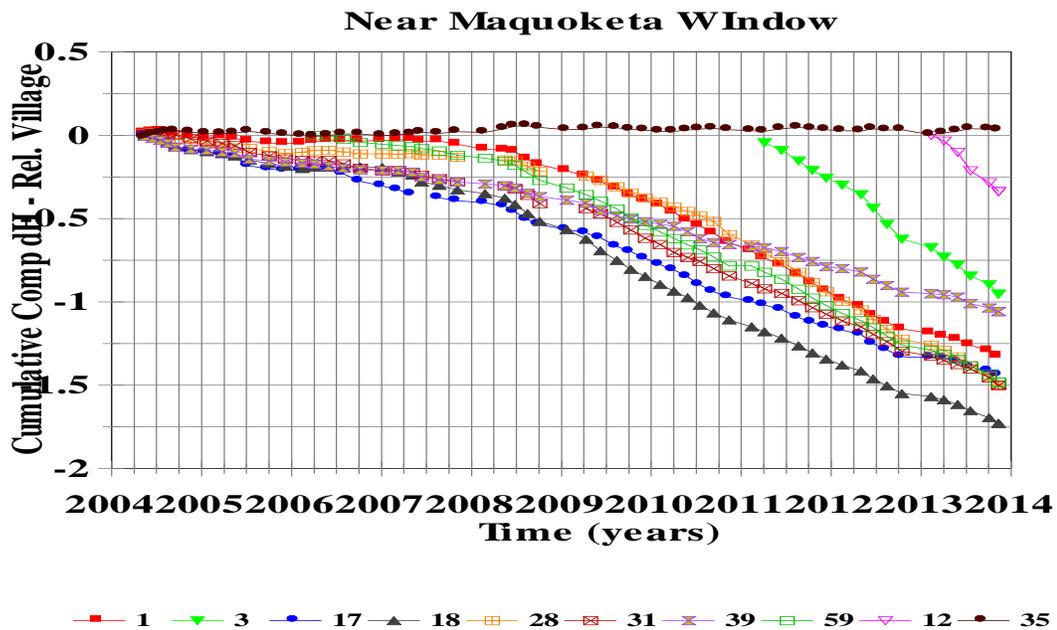
Figure 12 Change in groundwater level relative to Village average in wells near the hypothesized window through the Maquoketa Shale Well locations are shown in Figure 9. Well 35 serves as a control well; it is not near the suspected window.

Figure 12 shows the cumulative relative change in water level through time for all the wells near the hypothesized window. Note how most of the plotted wells show a relative decline through time which is similar to those seen for the entire SE part of Richfield (Figure 8) and for Wells 2, 12 and 60 from Reflections Village south (Figure 10). Drainage through the window could potentially affect wells across a broad part of the Village, not just those lying directly above it. This would explain why there are so many wells with a similar relative decline in Figure 11. It could also explain some portion of the unexpectedly large summer declines under Reflections Village.
